ERDC/EL SR-01-2

**Biological Assessment of Streams
Associated with the Northern Training
Complex at Fort Knox, Kentucky,
August 2000**

Barry S. Payne and William B. Green

February 2001

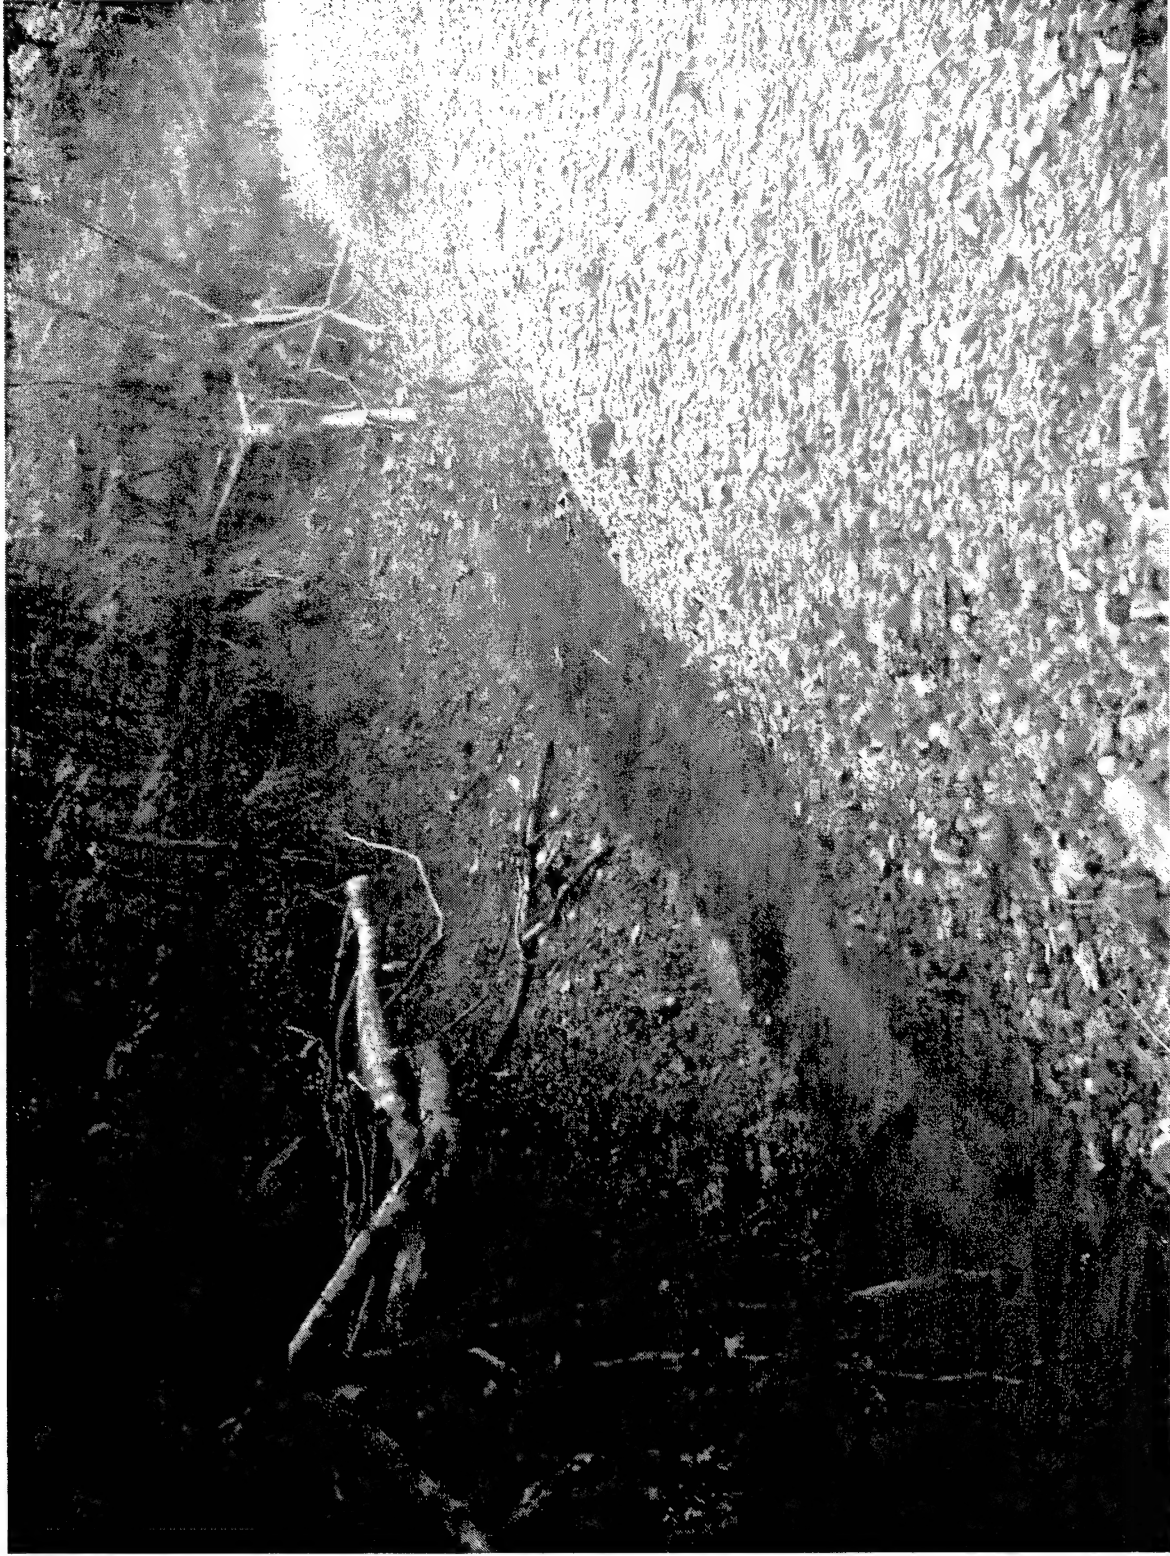
The upstream site (Site 1) in this creek was a narrow, linear pool along the right descending bank (Photograph 2). This pool along the cut bank was the deepest part of the streambed. The pool was approximately 150 feet long, averaged 2 to 4 feet wide, and water depth averaged 0.5 ft. Maximum depth was approximately 1.5 feet at the downstream end of the pool in a scour hole formed below a large tree. Substrate was mostly cobble with a substantial amount of gravel and sand with some organic debris (Table 2). Coarse particulate organic matter (CPOM, coarse particulate matter comprised of tree leaves, wood, and twigs) and organic muck (FPOM, fine particulate organic matter resulting from degradation of CPOM) were present in small quantity along the bottom of the pool. The remaining (dry) streambed at this site was a flat cobble riffle that extended from the pool to the left descending bank (Photograph 2).

Photograph 2. Upstream view of Site 1 in Cedar Point Branch showing pooled water along cut bank and cobble of dry streambed.

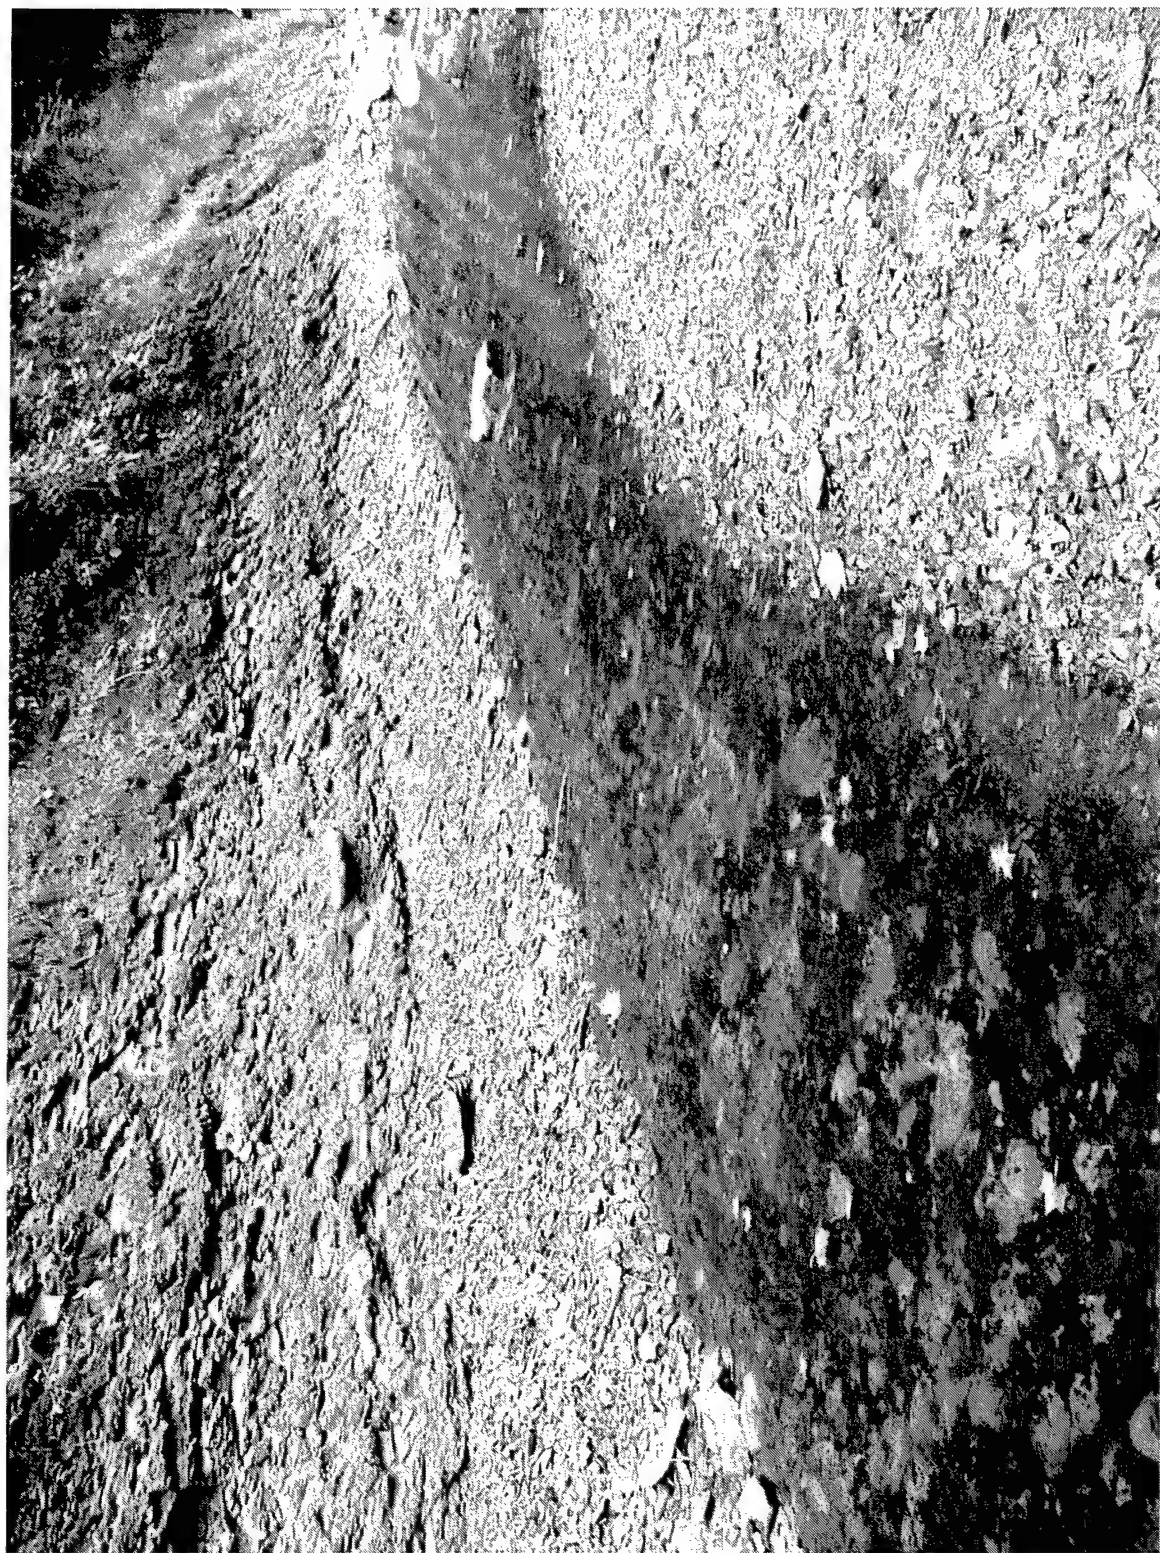
Site 2 was approximately 300 feet downstream of Site 1 and was a long (150 ft), shallow (0.5 ft), wide (10 ft) pool along the left descending bank (Photograph 3). The left bank was a vertical cliff of clay and substratum was "bedrock" of scoured, hard clay. Sand, gravel, and cobble were present along the right margin and both ends of this pool. Extensive FPOM littered the hard clay (Photograph 4). CPOM was abundant in a relatively deep pool (2.5 ft) at the upstream end of the entire pool. Water velocity was 0 ft/sec.

Photograph 3. Downstream view of Site 2 in Cedar Point Branch, a wide and shallow pool along the base of the vertical cliff that forms the left descending bank.

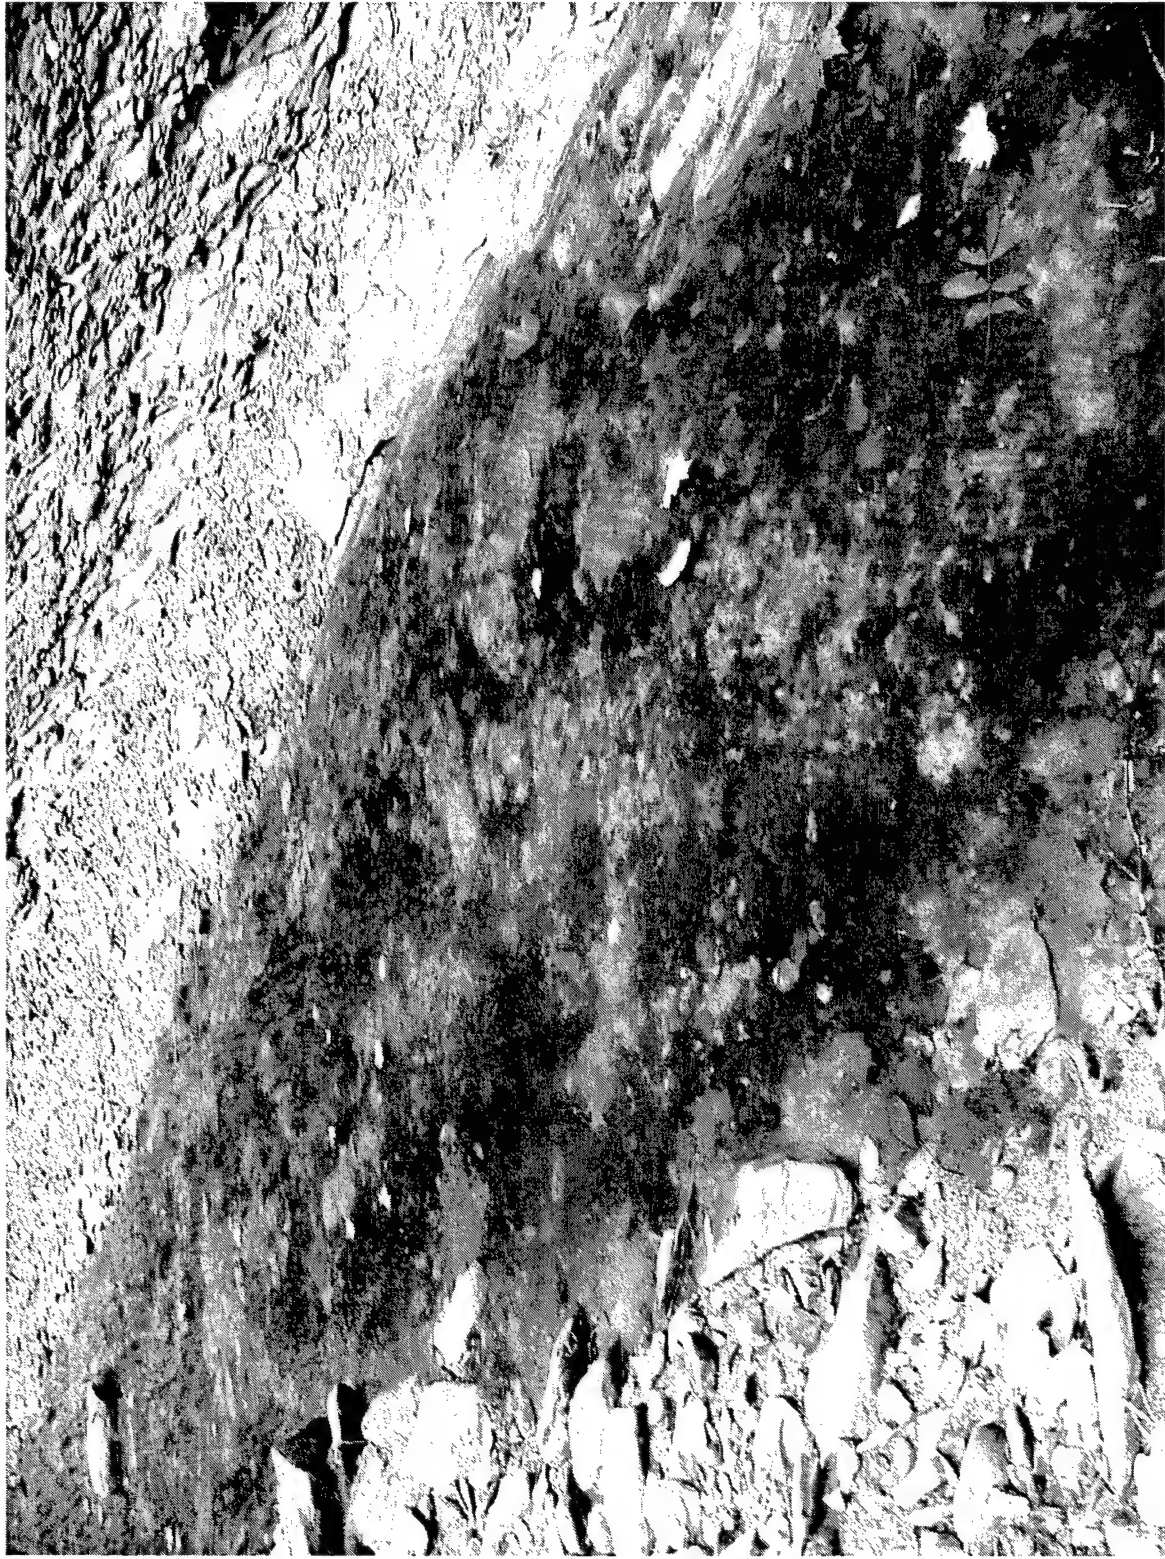
Photograph 4. Fine Particulate organic matter (FPOM) accumulated in Site 2 in Cedar Point Branch.

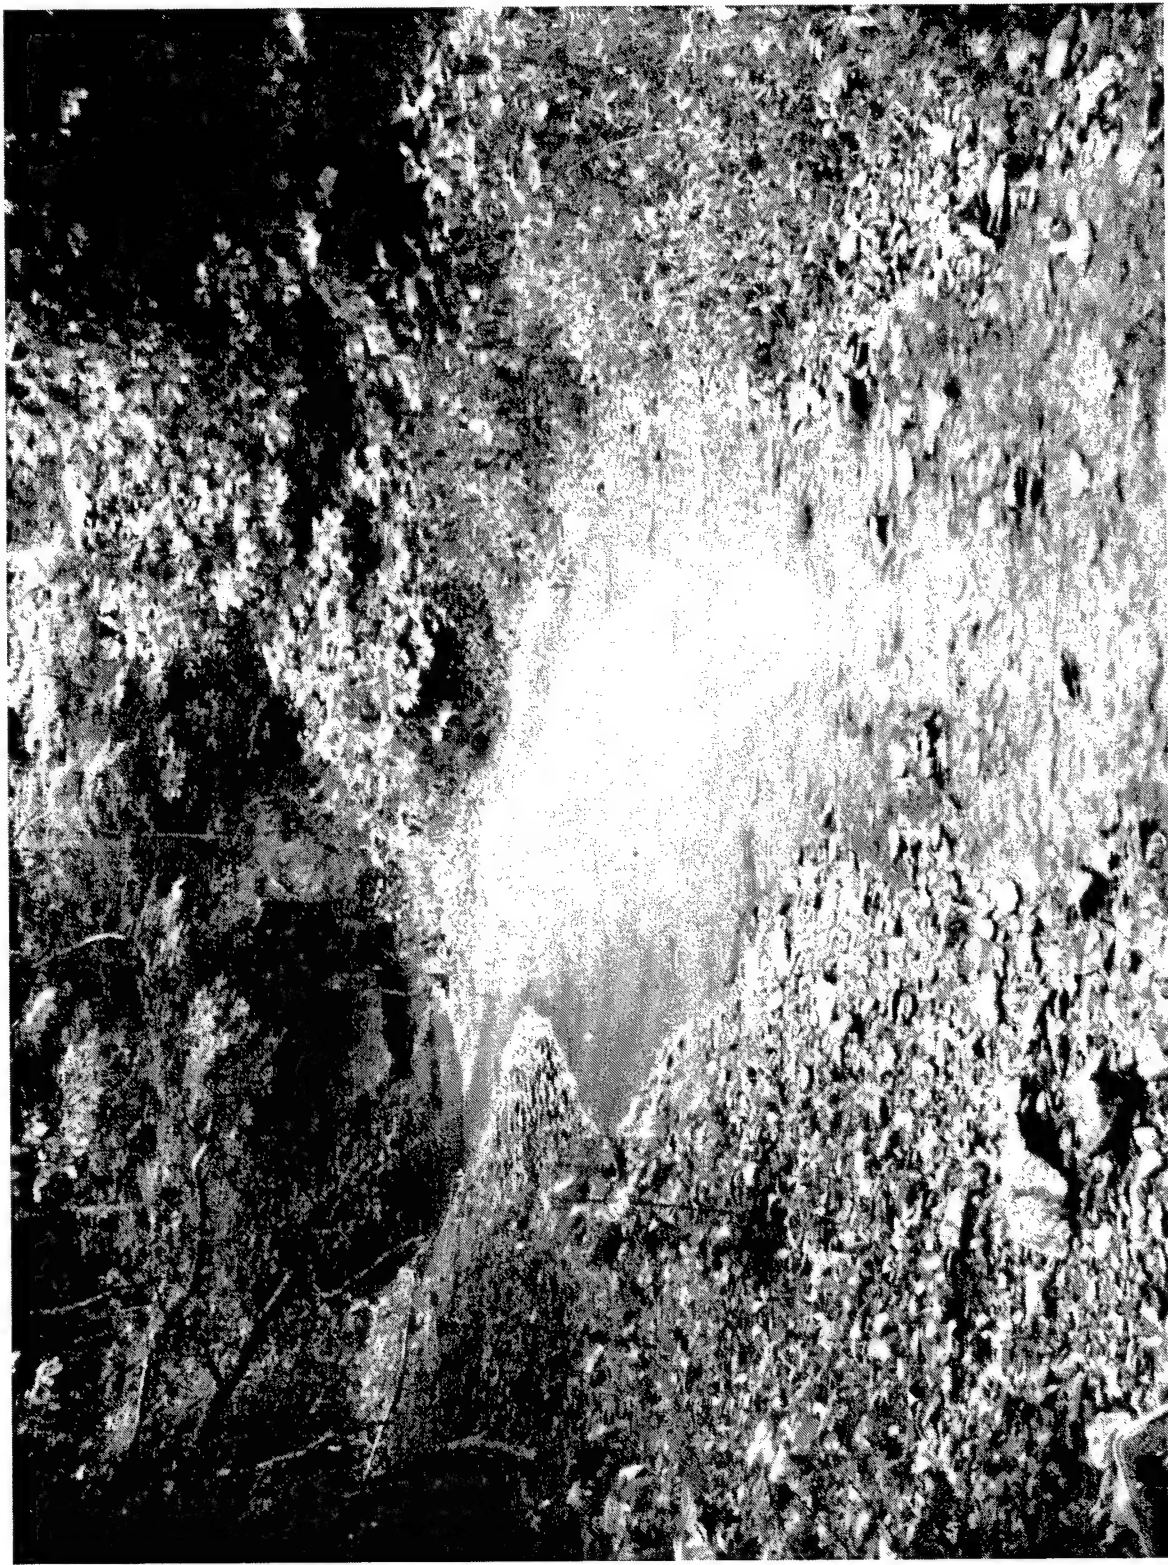
Castleman Creek was sampled at four locations. The three upstream sites (Sites 1-3, all in the valley leading toward Shepherd Cemetery) were similar in that the streambed at these locations was essentially an erosional riffle with a heterogeneous mix of cobble, gravel, sand, and hard clay at these three sites (Table 2; Photographs 5, 6 and 7). At each

Photograph 6. Upstream view of Site 2 in Castleman Creek.

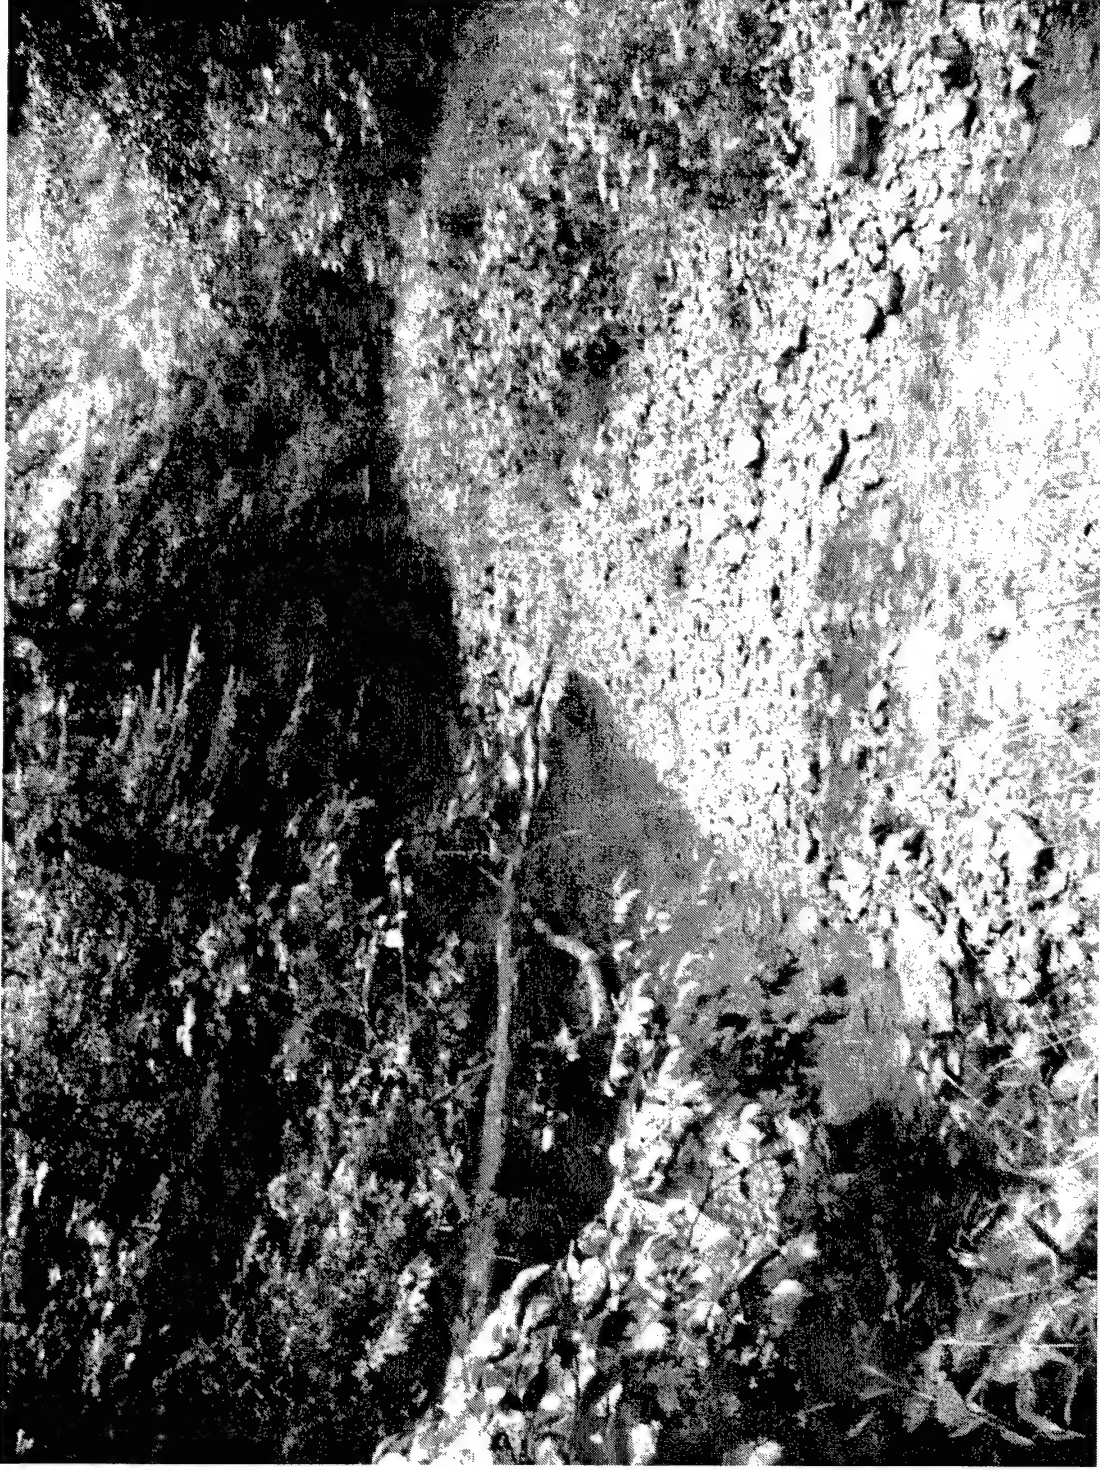
Photograph 7. Downstream view of Site 3 in Castleman Creek showing herbaceous and young woody vegetation growing in dry cobble streambed.

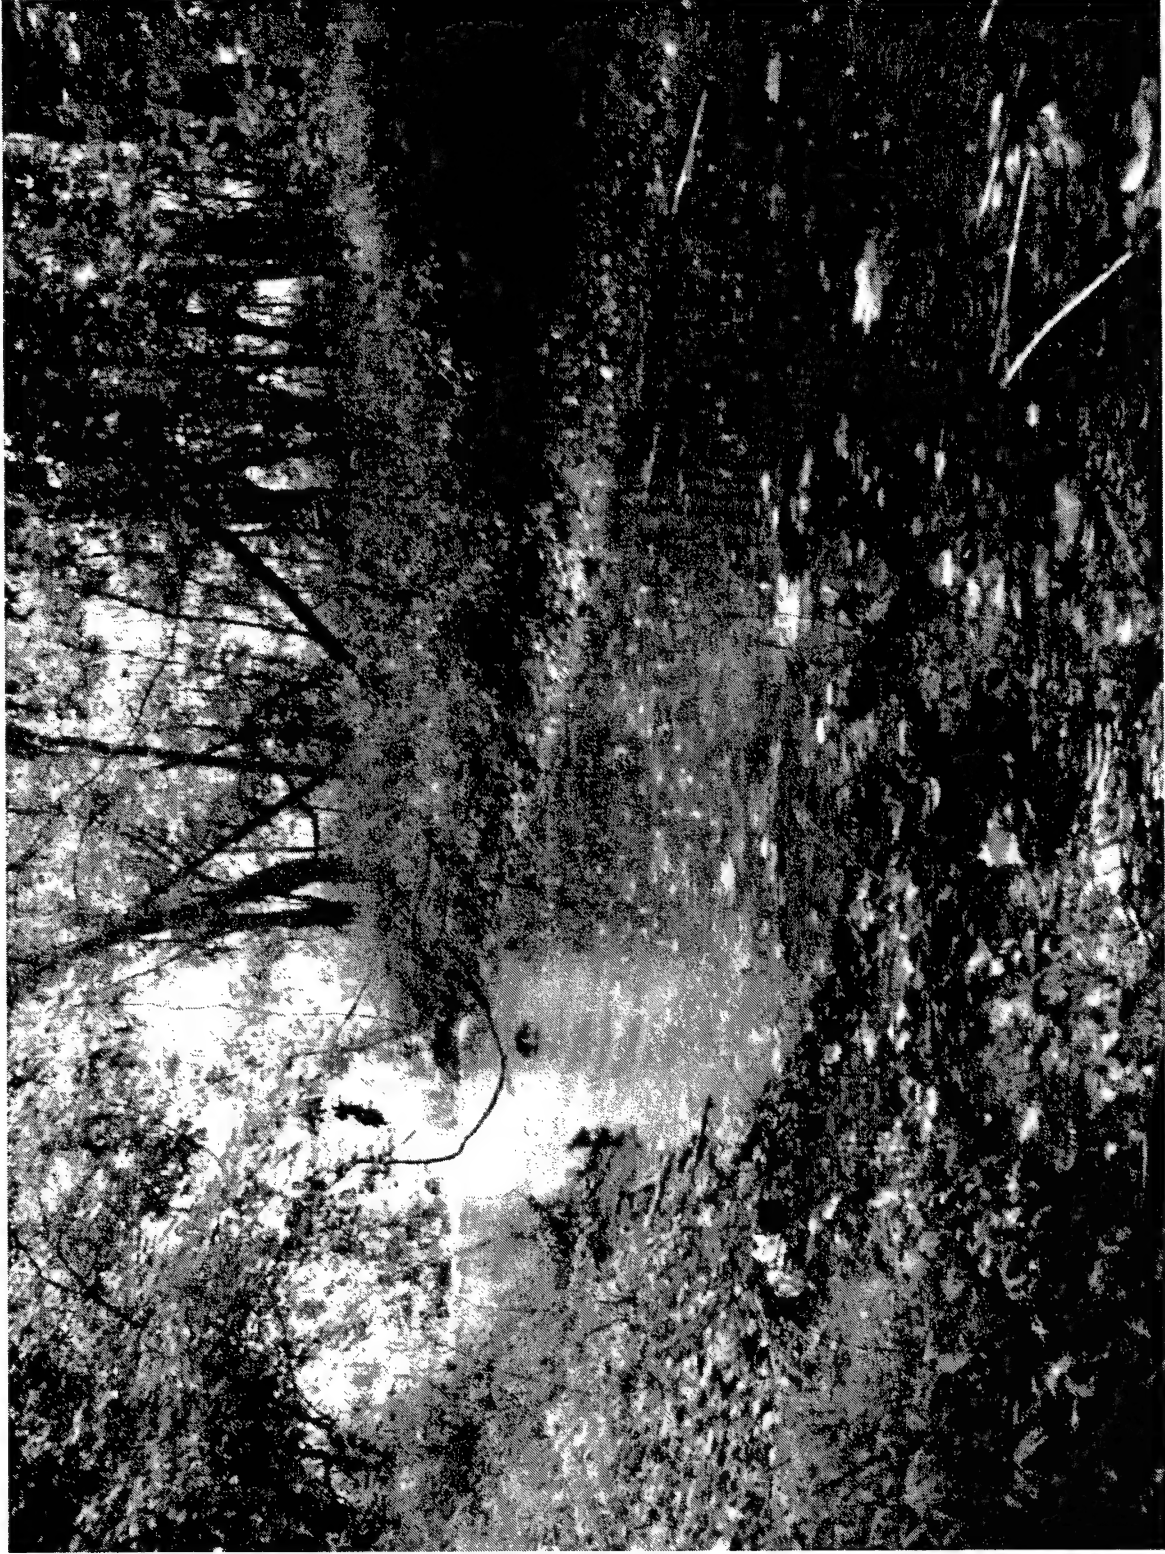
site, pools with accumulated leaf litter were associated with scoured holes below root wads of large trees along the bank. In contrast, the downstream site (Site 4) was on the alluvial floodplain of the Salt River just upstream of Duck Lake and Pitts Point Road; this site was depositional with deep (and anoxic) deposits of soft clay, silt, and leaf litter (Table 2; Photograph 8).

Photograph 8. Downstream view of Site 4 in Castleman Creek with the sunny opening downstream indicating the location of Pitts Point Road.

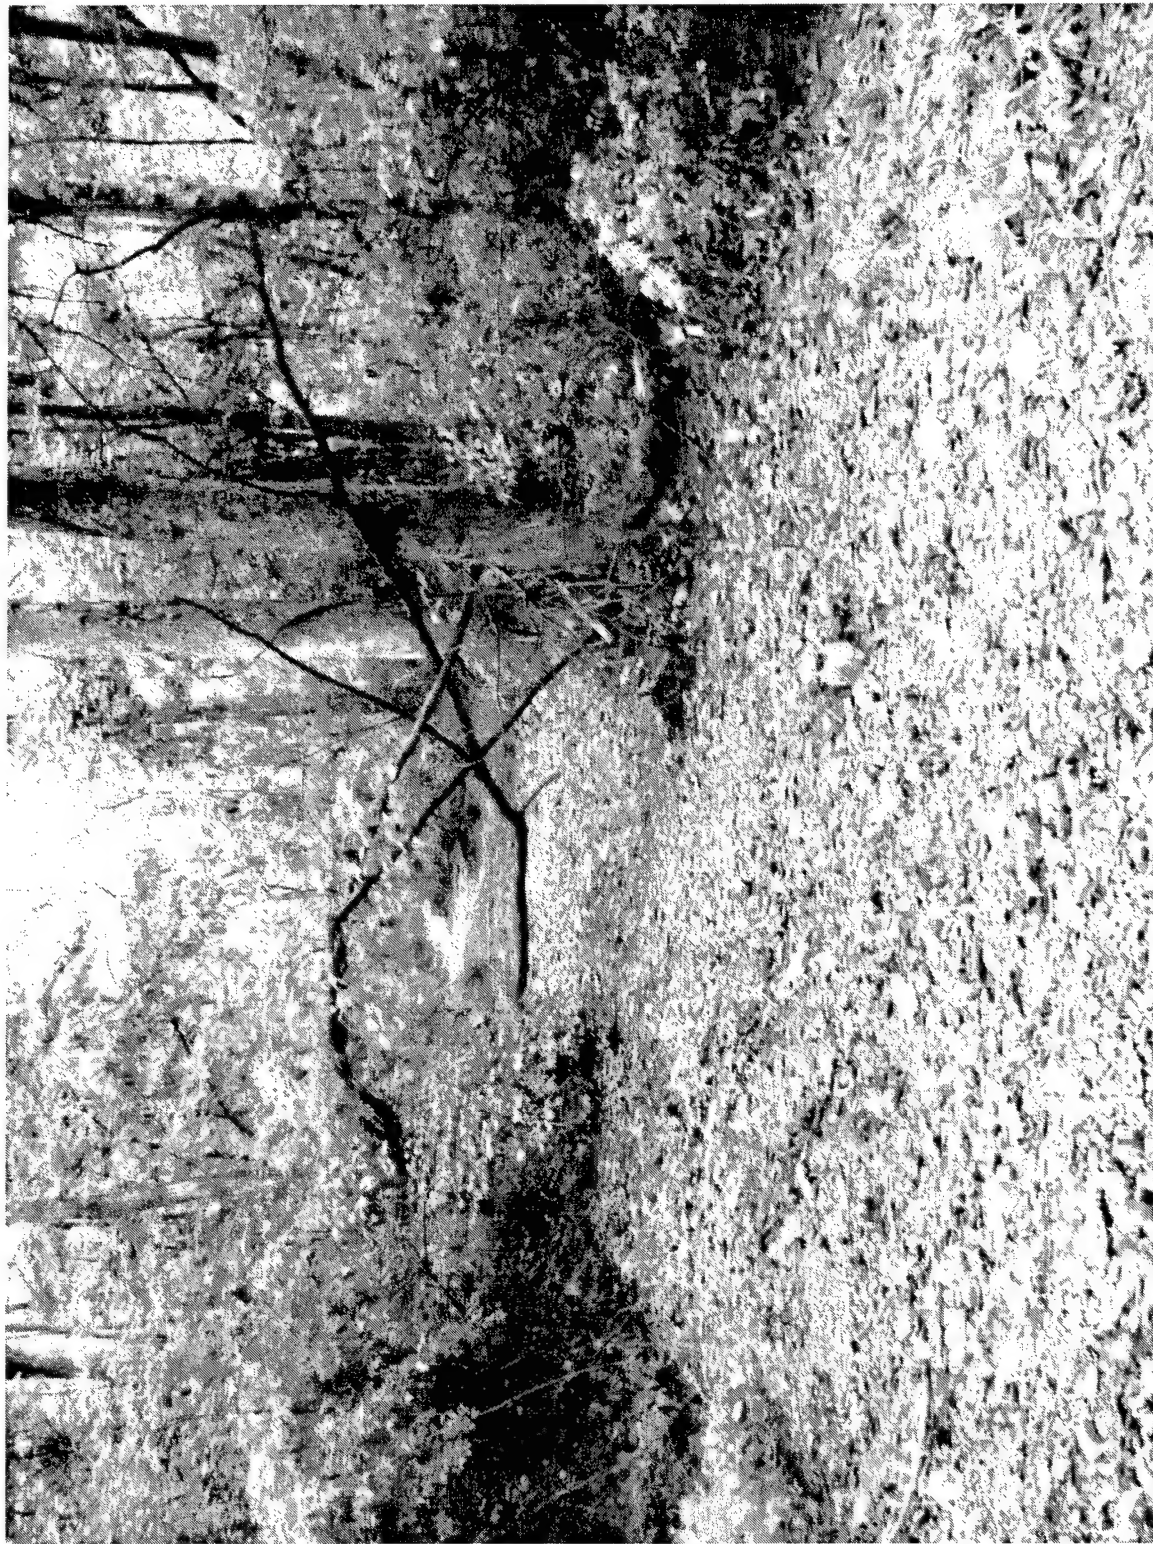
Two sites were investigated in this drainage. Both were dry. The upstream site was a 30 ft wide channel of large and medium cobble with some gravel and sand (Photograph 9). Bank height was approximately 2 to 3 feet. Scour holes below large trees at the edge of the channel provide the only pool habitat in an otherwise continuous riffle. No water was found even in these scour holes. The downstream site (Site 2; Photograph 10) was near Pitts Point Road in the same general area as the downstream site in the closely adjacent Castleman Creek. The channel was very similar to that at Site 1. One scour hole held a few gallons of water; however, the near total lack of permanent water precluded sampling of Woodland Creek. The cobble streambed was evidence that this creek occasional conveys swift scouring flow despite being dry during low flow seasons.

Photograph 9. Upstream view of Site 1 in Woodland Creek showing the dry gravel and cobble streambed and a small scoured depression at the base of a large tree on the left descending bank.

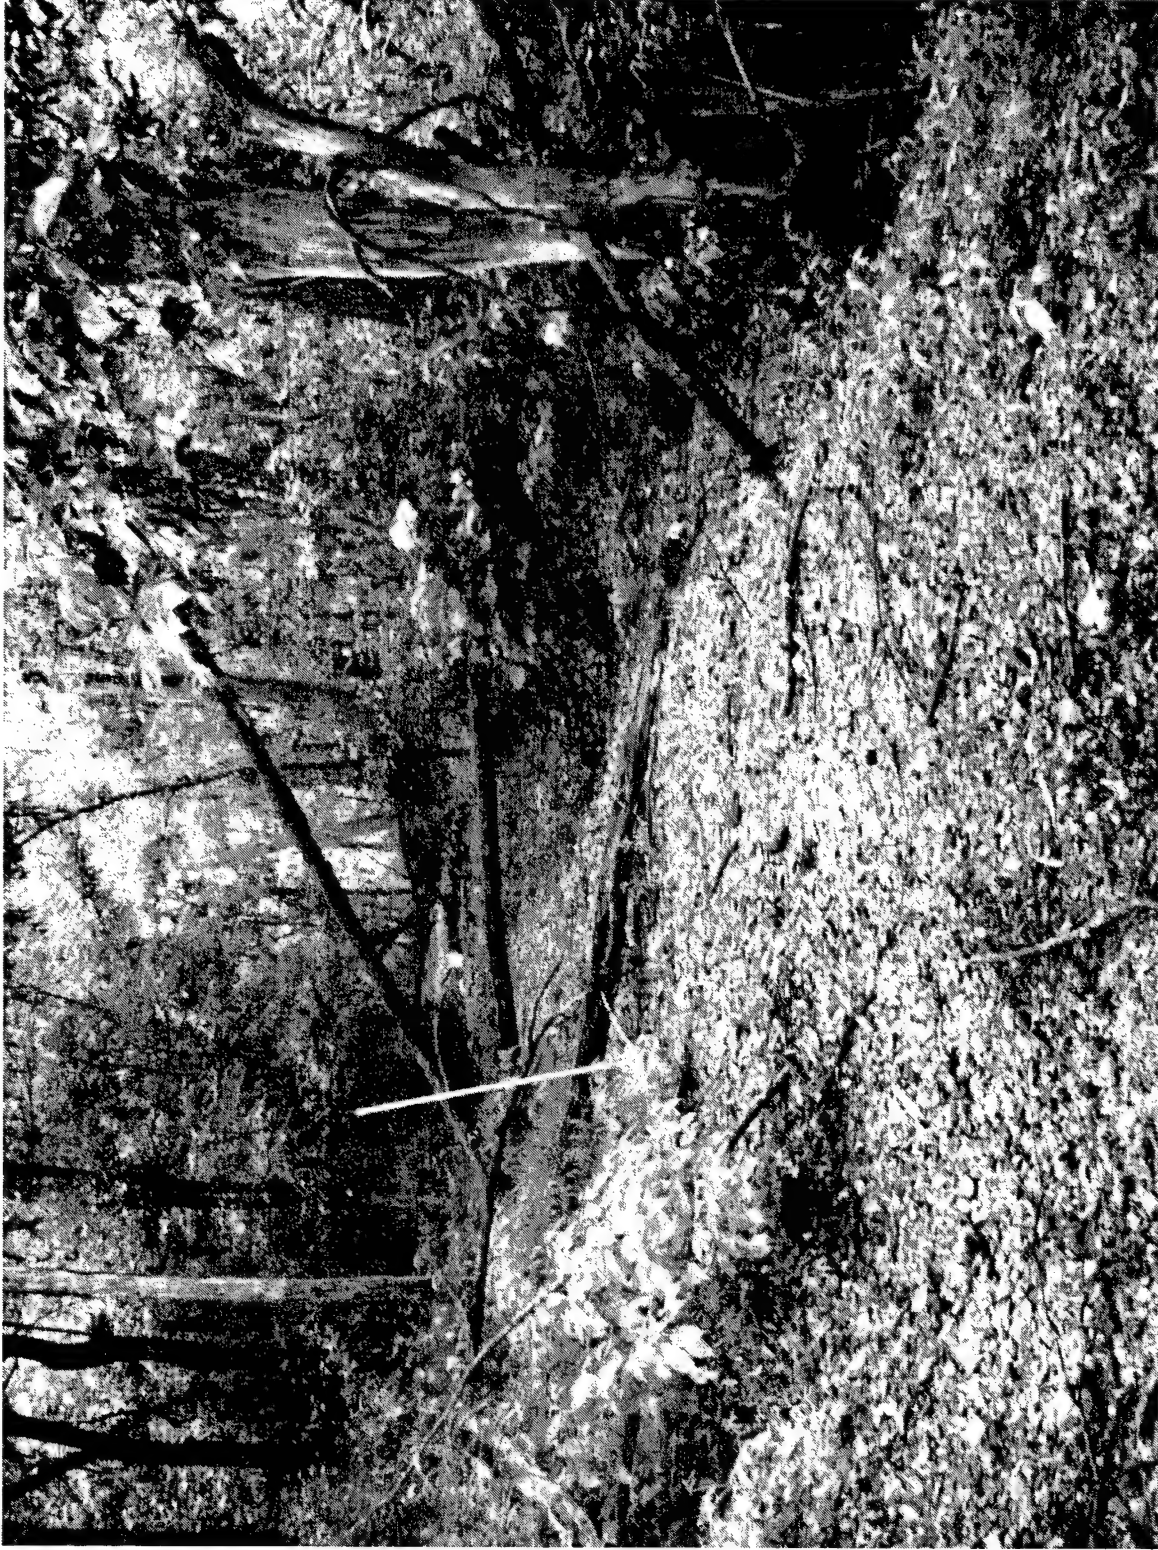
Photograph 10. Downstream view of Site 2 in Woodland Creek showing dry gravel and cobble streambed.

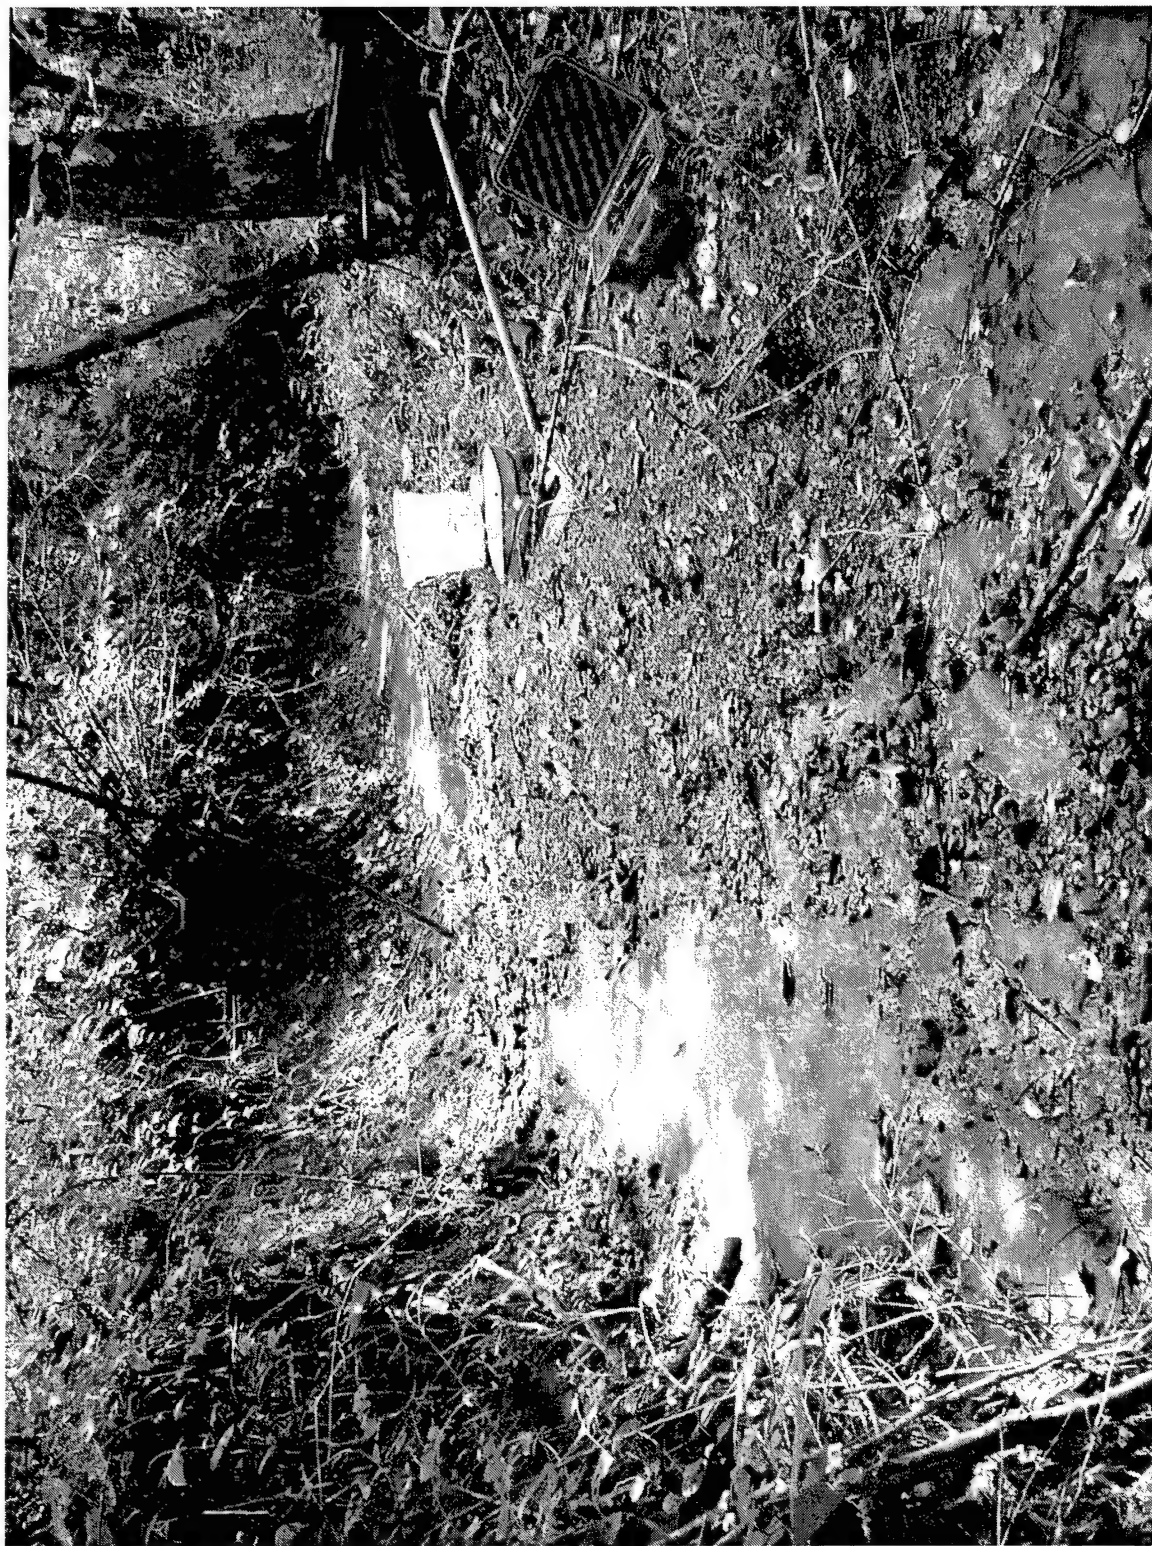
Site 1 was a narrow pool along the left descending bank, approximately 120 ft long, 3 ft wide, and 6.5 feet deep (Photograph 11). The stream channel was only 10 to 15 ft wide; bank height was 3 to 4 feet. Channel substratum was a mix of some cobble with much gravel, silt, and soft clay (Table 2). Clay and leaf litter deposits smelled of hydrogen sulfide when disturbed. There was no evidence of organic pollution. Surrounding woodlands were second growth on abandoned farmlands (old barbed wire fencing ran along the left descending bank).

Photograph 11. Downstream view of Site 1 in Mud Creek tributary showing slightly turbid pooled water mainly along the left descending bank.

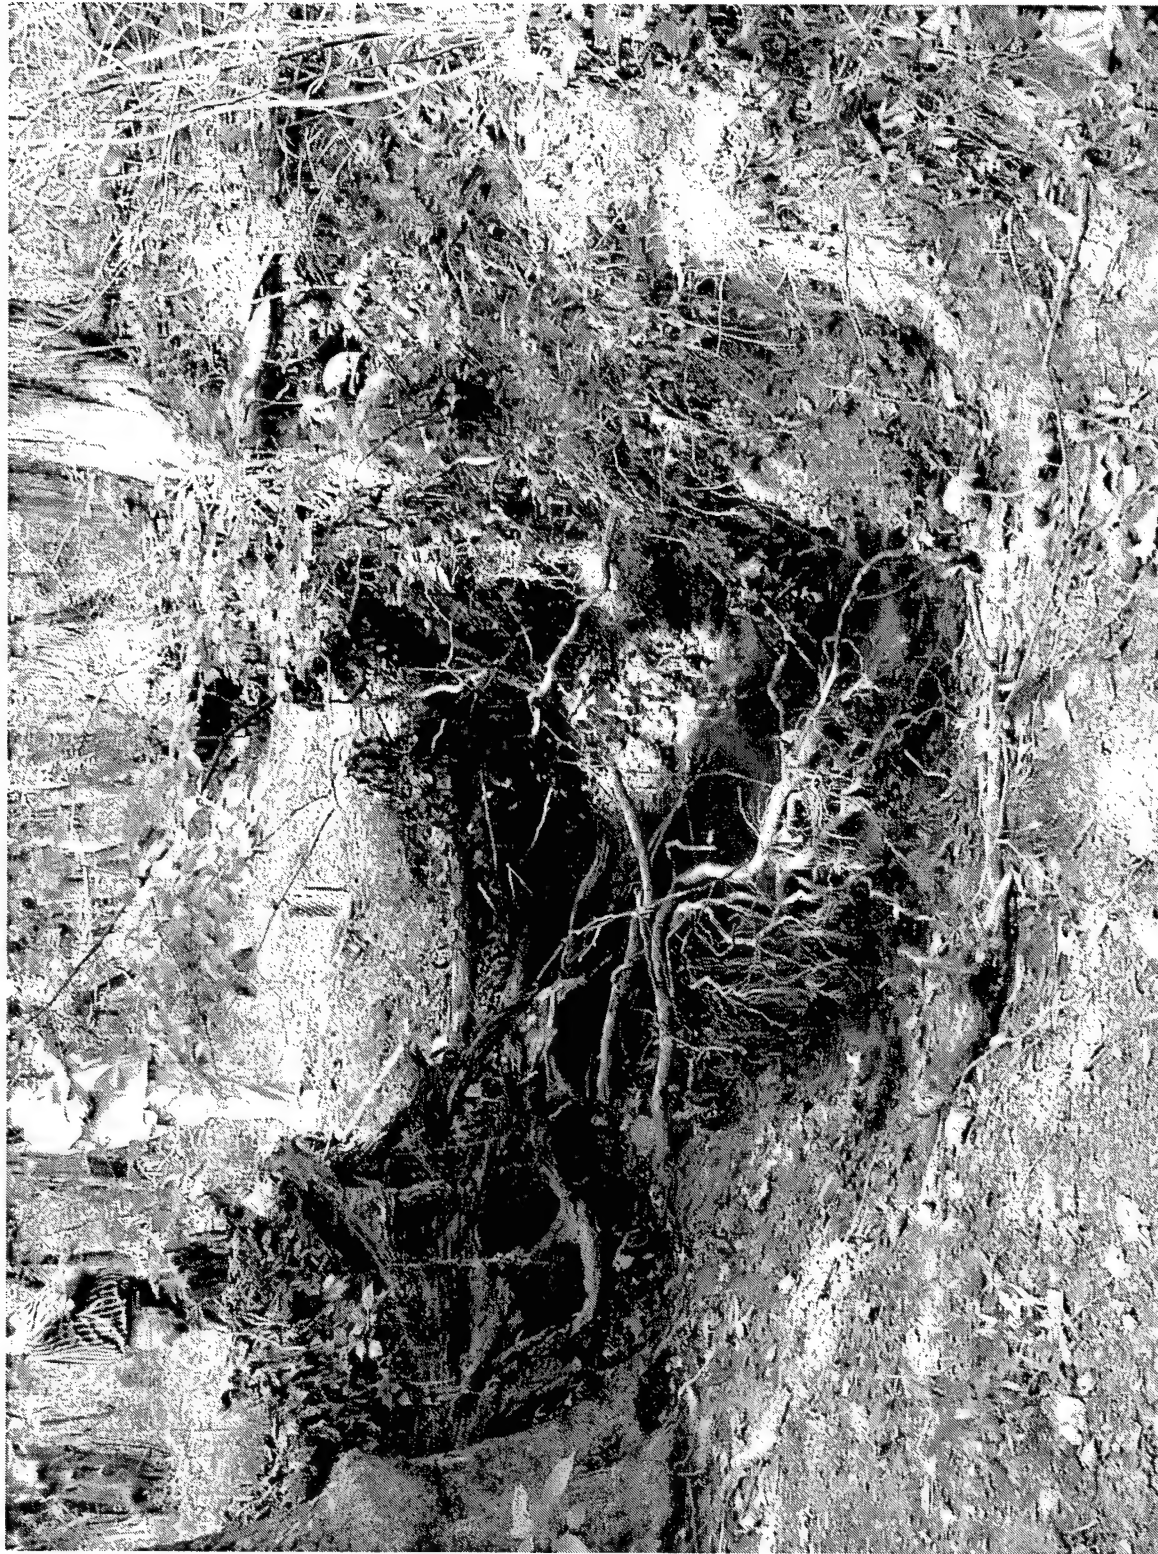
Site 2 was approximately 300 ft downstream (and was the next available pool of water). This site was a deep (3 ft) but small (4 ft diameter) scour hole under a root wad of large tree along the left descending bank (Photograph 12). Substrate was clay with dense leaf litter (Table 3). The substrate smelled strongly of hydrogen sulfide upon sampling.

Photograph 12. Upstream view of Site 2 in Mud Creek tributary a pool of water in a scoured area where the stream bends between two large trees on the banks.

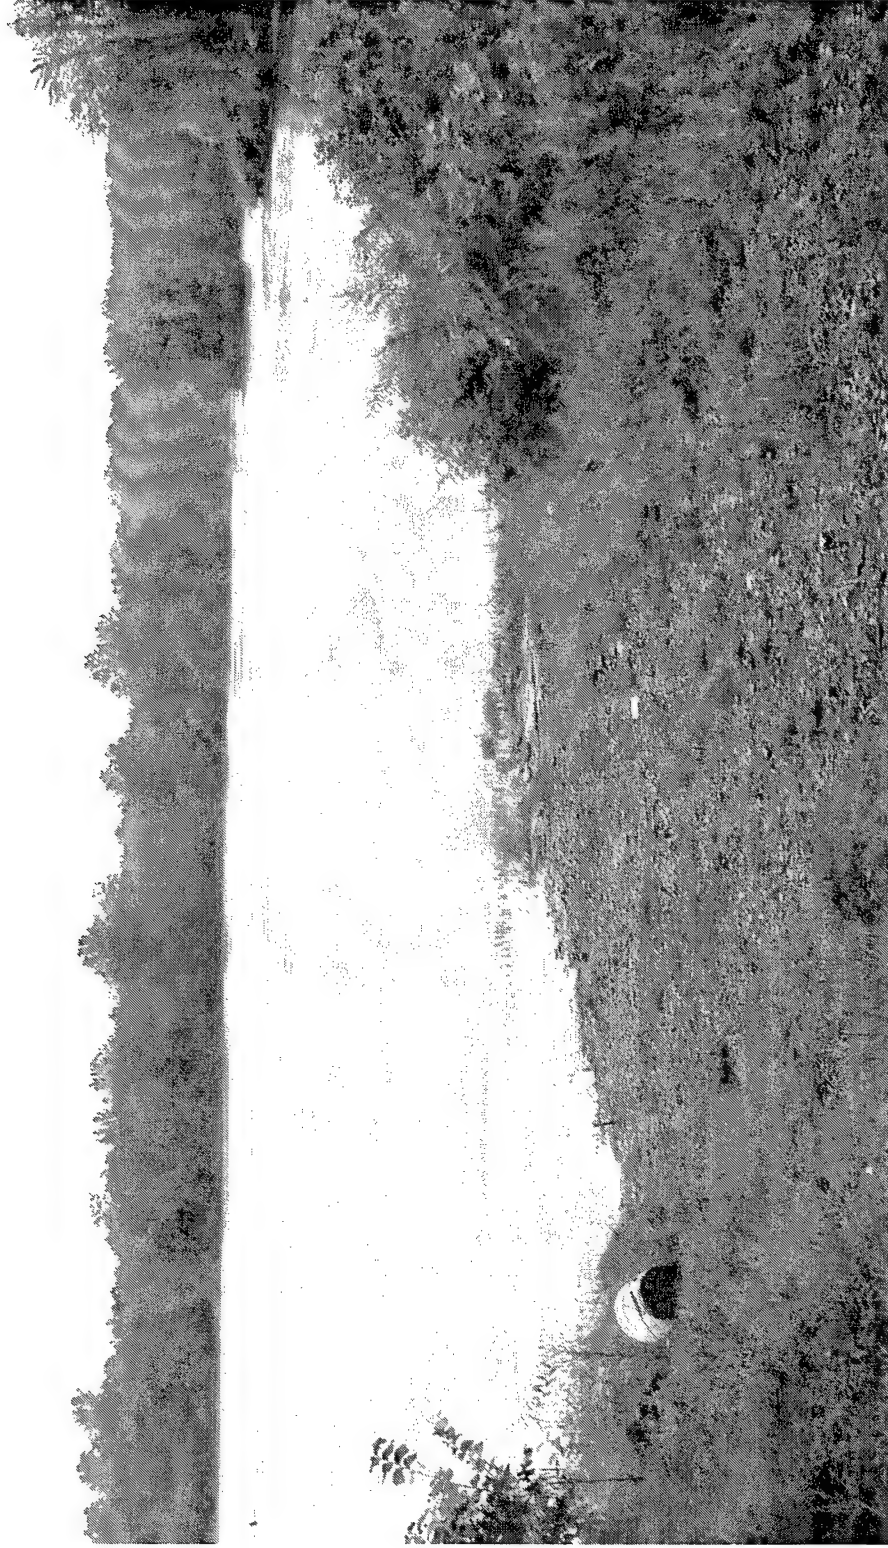
The littoral margins of these lakes, the focus of sampling, consisted of macrophytes (heavily dominated by the submersed macrophytic algae, *Chara*) growing from a soft mud-muck bottom. Plants at Duck Lake (Photograph 15) were healthy and green, while those in Wilcox Lake (Photograph 16) were blackened by anaerobic conditions. The bottom at both lakes smelled strongly of hydrogen sulfide when disturbed.

Photograph 15. Upstream portion of Duck Lake.
